LONDON- WEST MIDLANDS ENVIRONMENTAL STATEMENT

CFA23-26 | Balsall Common to Curzon Street
**Ecological baseline data: designated sites,
habitat surveys and flora (EC-001-004)**
Ecology

Appendix EC-001-004

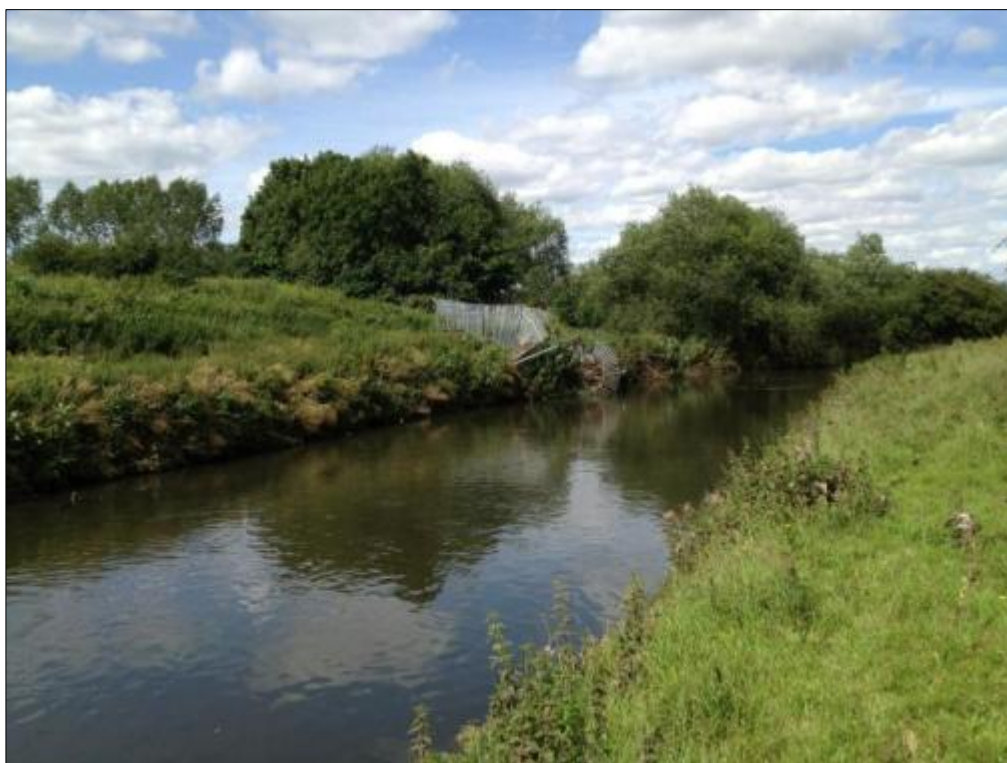
Figure 41: Photograph of River Tame SLINC - Section 4 (CFA25), photo reference 040-RS1-166004-P-260712

- 7.4.12 The River Tame SLINC was a large, realigned watercourse. It had stone/concrete banks with planted trees, localised areas of rough grass, bramble and tall herbs. The bed substrate was natural with extensive beds of river water crow-foot. The water depth along this section of the River Tame SLINC increases rapidly by almost 2m following heavy rainfall, but also quickly recedes. The channel is steep sided with few overflow points.
- 7.4.13 RCS were undertaken on four different sections of the River Tame SLINC, all of which were within the Castle Bromwich and Bromford area (CFA25). The results of this survey are shown in Table 51, Table 52, Table 53 and Table 54. Hand drawn figures are shown in Figure 32, Figure 33, Figure 35, Figure 36, Figure 38 and Figure 40. Photographs of the sections of river can be found in Figure 34, Figure 37, Figure 39 and Figure 41.

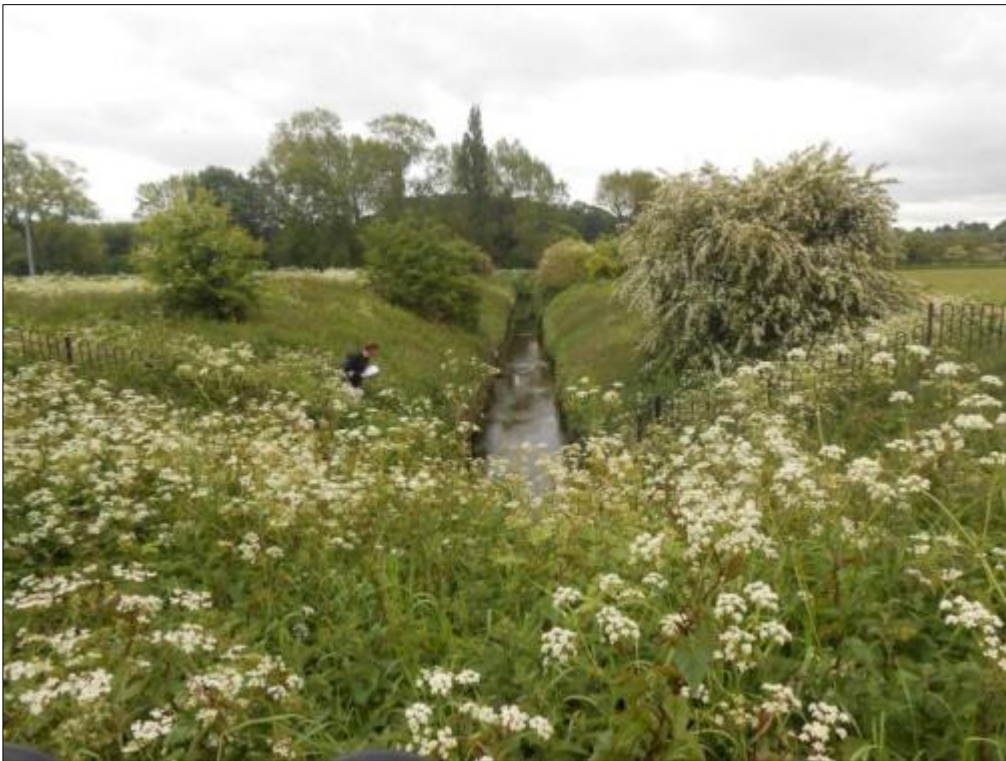
Figure 43: Photograph of Plants Brook (CFA25), photo reference 040-RS1-166005-P-110613-P1

- 7.4.14 Plants Brook was a small, realigned and deepened watercourse. It had stone/concrete banks and stream-bed, which showed accumulation of gravels and sands over a brick substrate. Some aquatic vegetation was present in the channel at the time of survey as well as on the margins of the watercourse.
- 7.4.15 Plants Brook was surveyed, using RCS, as shown in Table 55 and by the hand drawn figure shown in Figure 42. Photographs of this section of river can be found in Figure 43, Figure 44, Figure 45 and Figure 46.

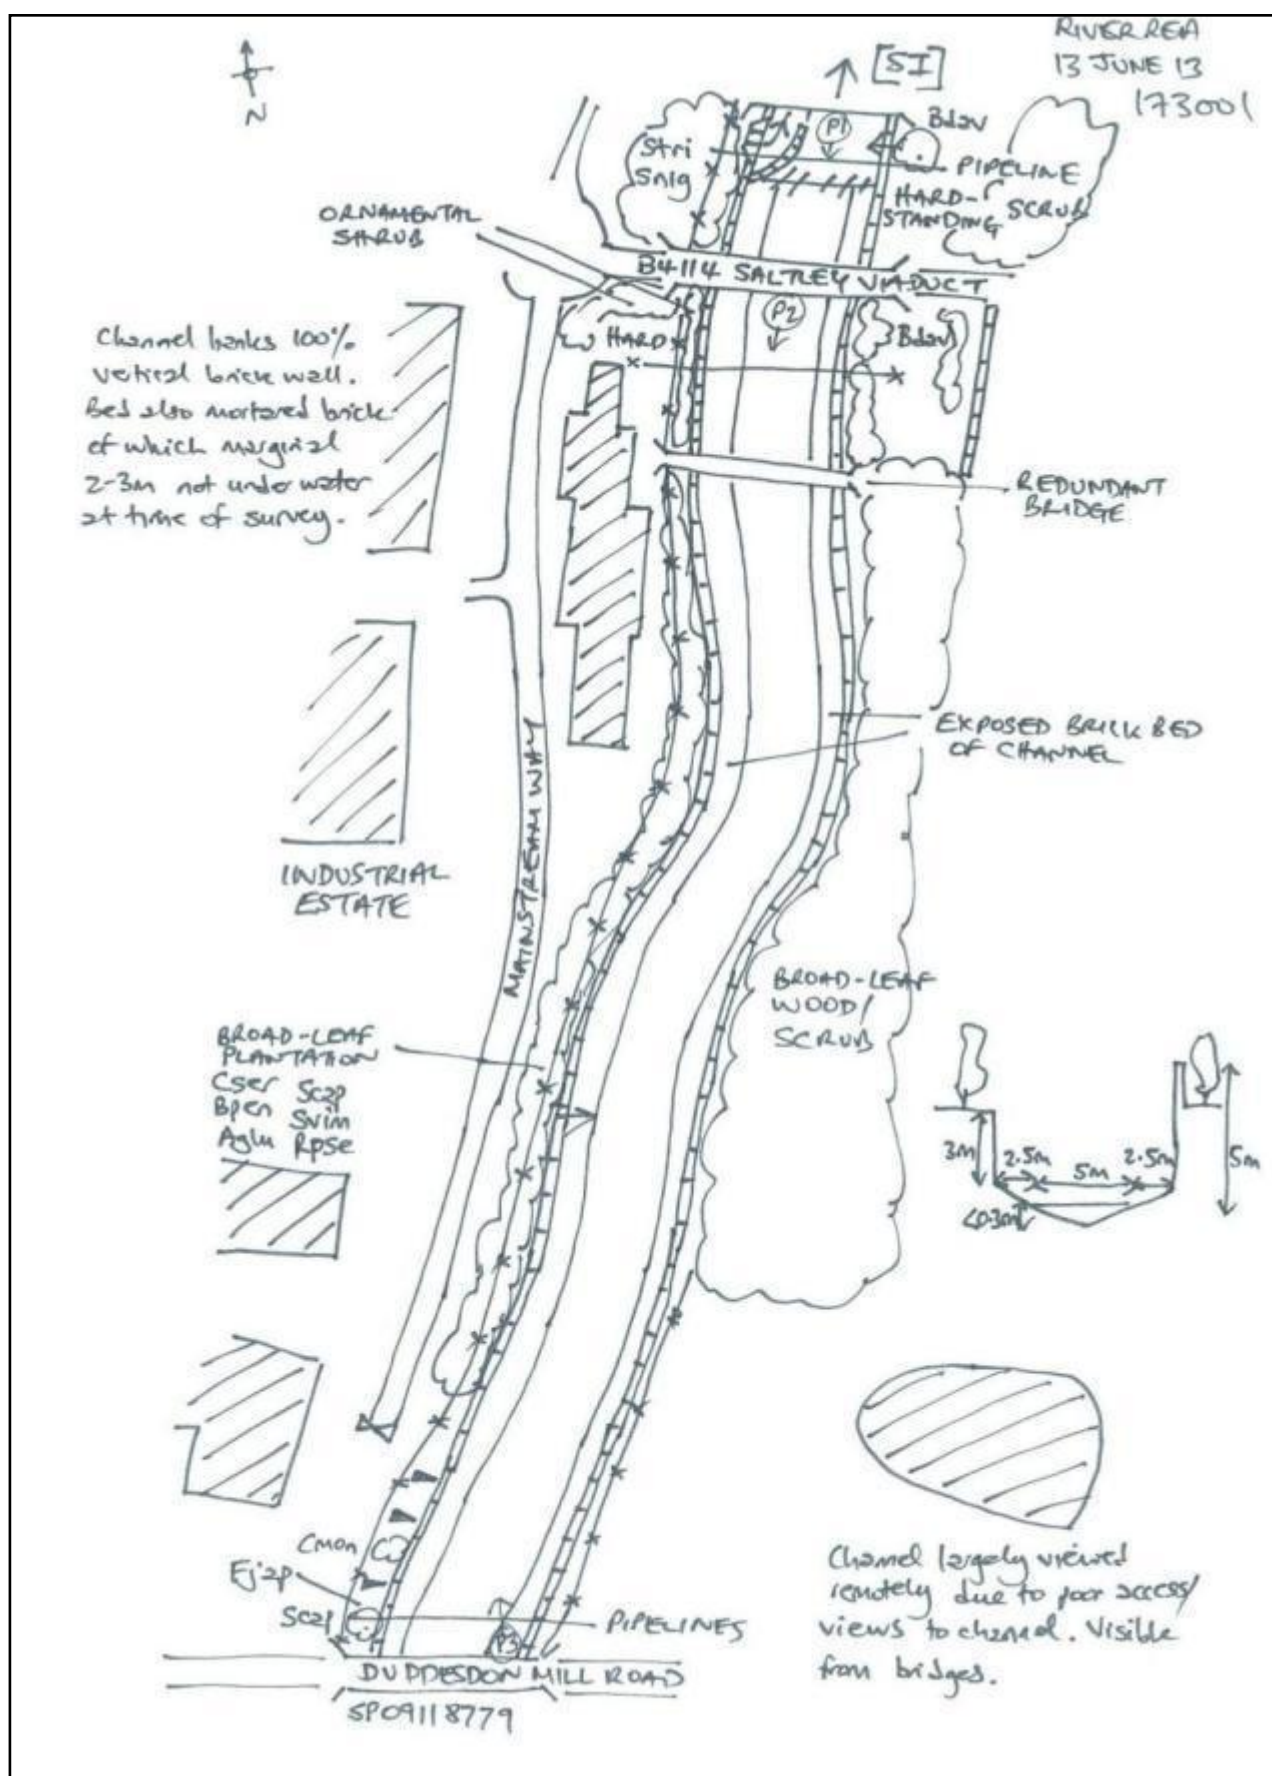
Figure 50: RCS hand drawn map for River Rea - Section 1 (040-RS1-173001).

- 7.4.18 The River Rea was a moderate sized, heavily altered (re-aligned) watercourse. No aquatic vegetation or marginal vegetation was present at the time of survey.
- 7.4.19 RCS were undertaken on two different sections of the River Rea. The principal results of this survey are shown in Table 57 and Table 58. Hand drawn figures are shown in Figure 50 and Figure 54. Photographs of the sections of river can be found in Figure 51, Figure 52, Figure 53 and Figure 55.
